DEFECTS AND FAILURES OF SOVIET STRUCTURES

REPORT NO. 94

Air Information Division, Structural Engineering Section

April 1958

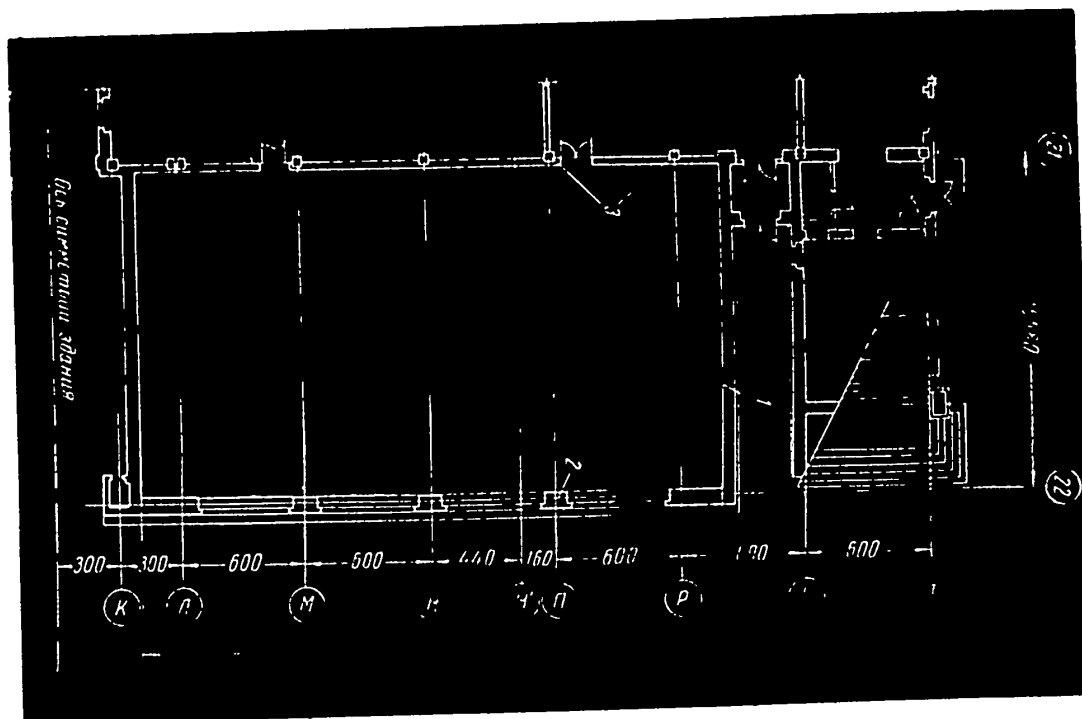
1. Training hall; 2. Collapsed pier; 3. Precast reinforced concrete columns

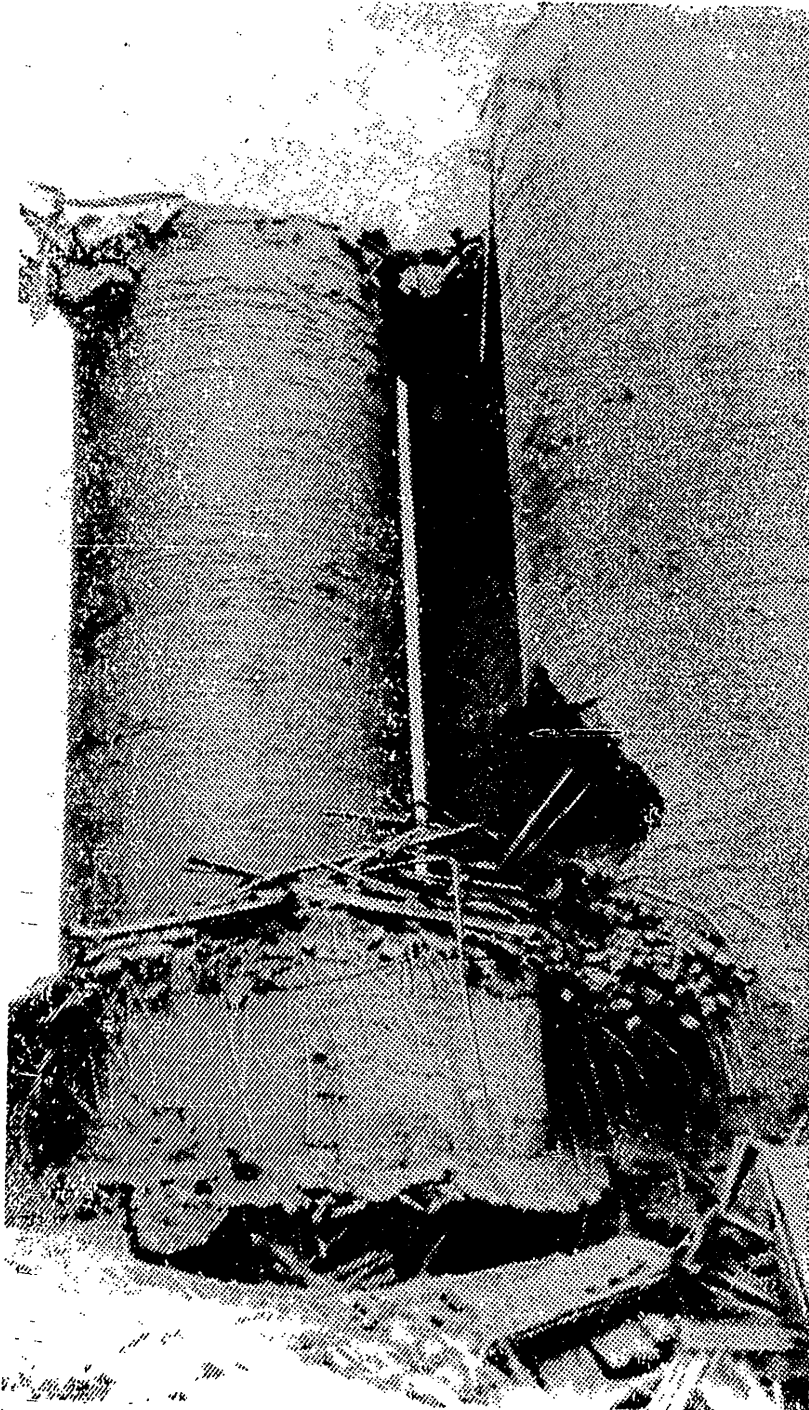
SILLO NO.7 AFTER THE COLLAPSE (Bryansk factory)
Source: Moscow TsINIS. Causes of Structural Failures, p. 44. (TH3401.M7)

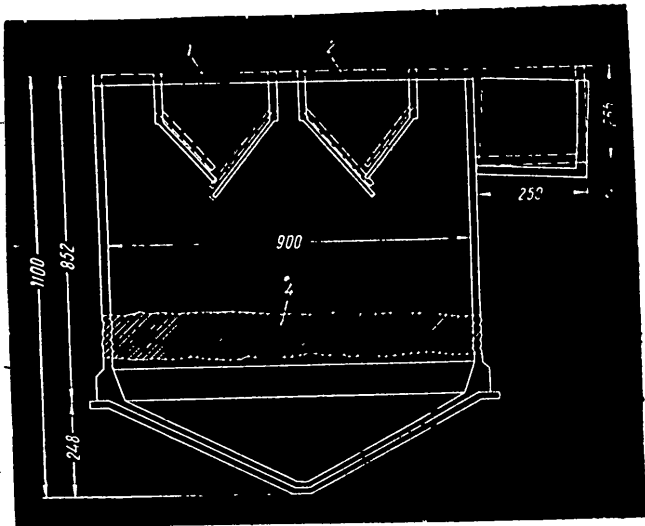
- 1. Tank level at erection; 2. Tank level after wall disintegration; 3. Silt chamber after settlement; 4. Crumbled zone of the wall.

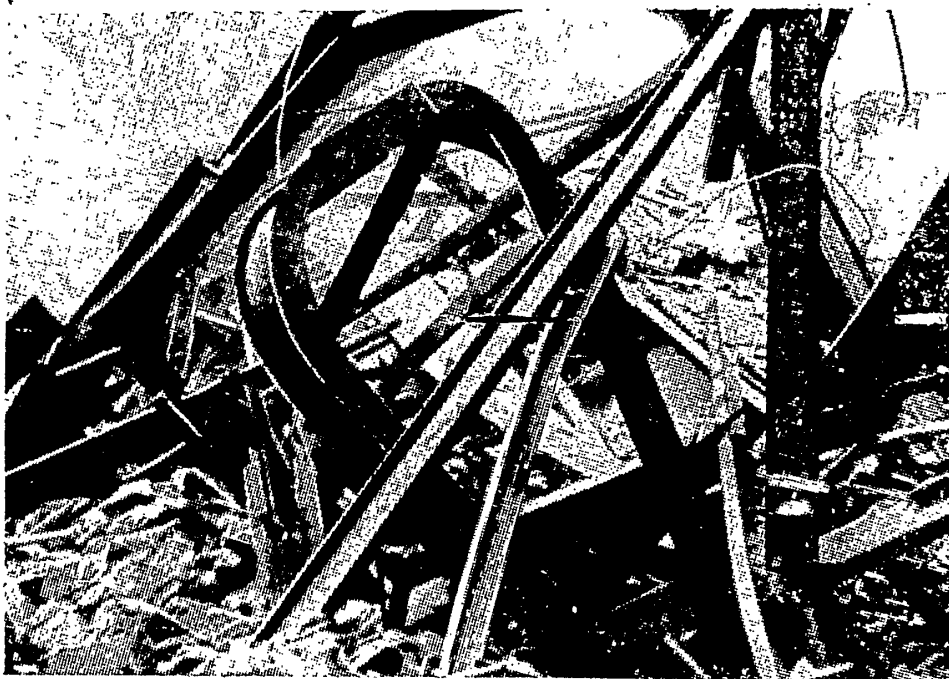
Western semi-arch (axis 28) after collapse

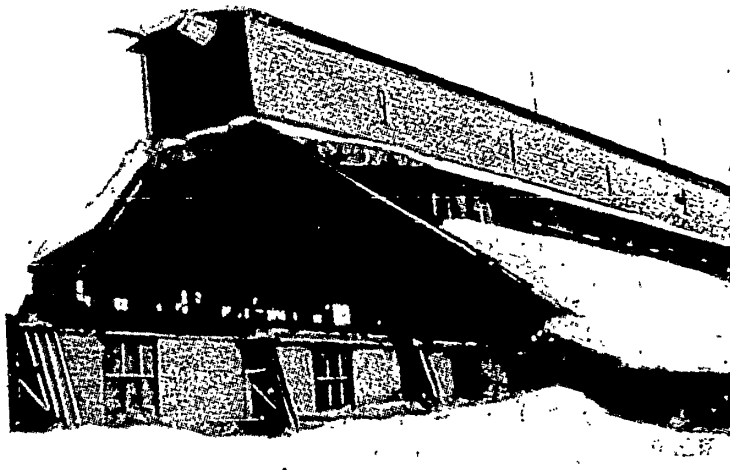
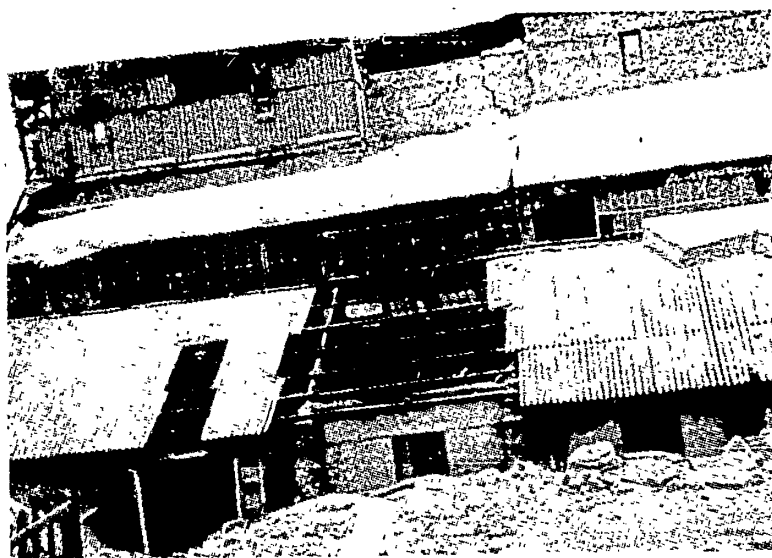
Views of snow load on the damaged roof

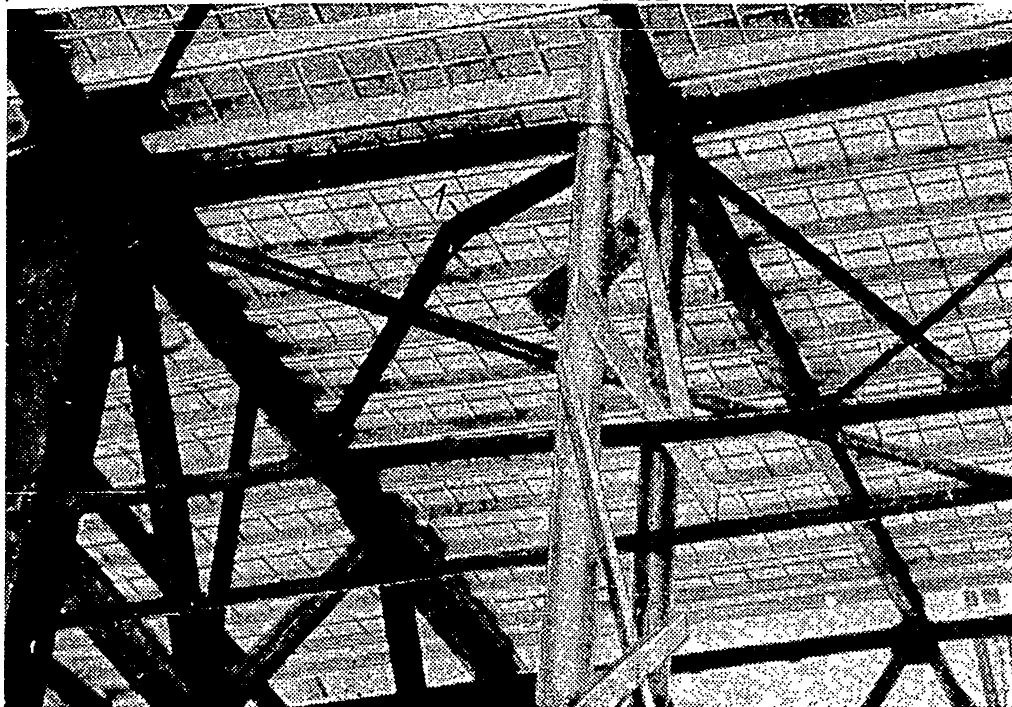
Fig. 1. Purlin carrier truss (1-Buckled web diagonal)
